## **Demonstration of Thermoplastic Composite I-Beam Design Bridge at Camp Mackall, NC**

Final Report on Projects FY08-16 and FY09-31

Under Installation Technology Transition Program (ITTP) Project FY08-16, "Innovative Recycled-Plastic I-Beam Bridge for Vehicular Traffic" and Project FY09-31, "Phase II, Load Testing and Tech Transfer for Design for Bridges on Military Installations for Military Vehicles."

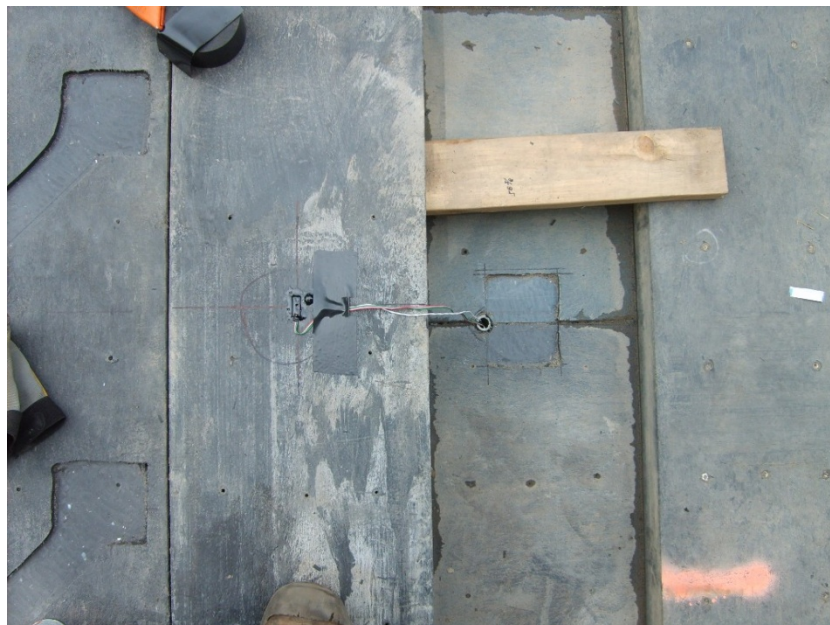
Figure 31. Strain and temperature gauges are visible near center of this photo.

In order to evaluate and verify long-term performance, Bridge T-8518 was instrumented to measure deflections and strains on various components (Lampo et al. 2011; Figure 31 and Figure 32). These instruments included 12 displacement gauges to measure deflections/displacements under load and during changes in temperature to an accuracy of 0.01 inches (0.25 mm), and 10 resistance-type strain gauges adhered directly to the bridge structure to measure strains within the range of  $\pm 3,000$  microstrain. These gauges compensated for temperature and humidity effects, as necessary, to provide accurate strain readings.

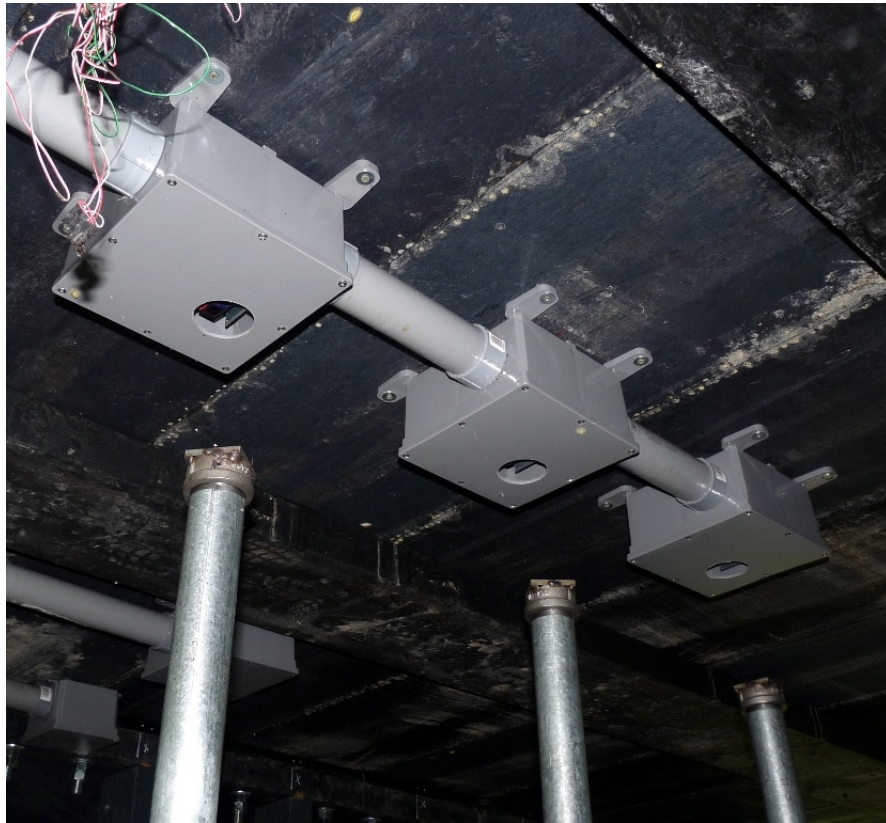
Figure 32. Laser sensors to measure displacements at midspan.

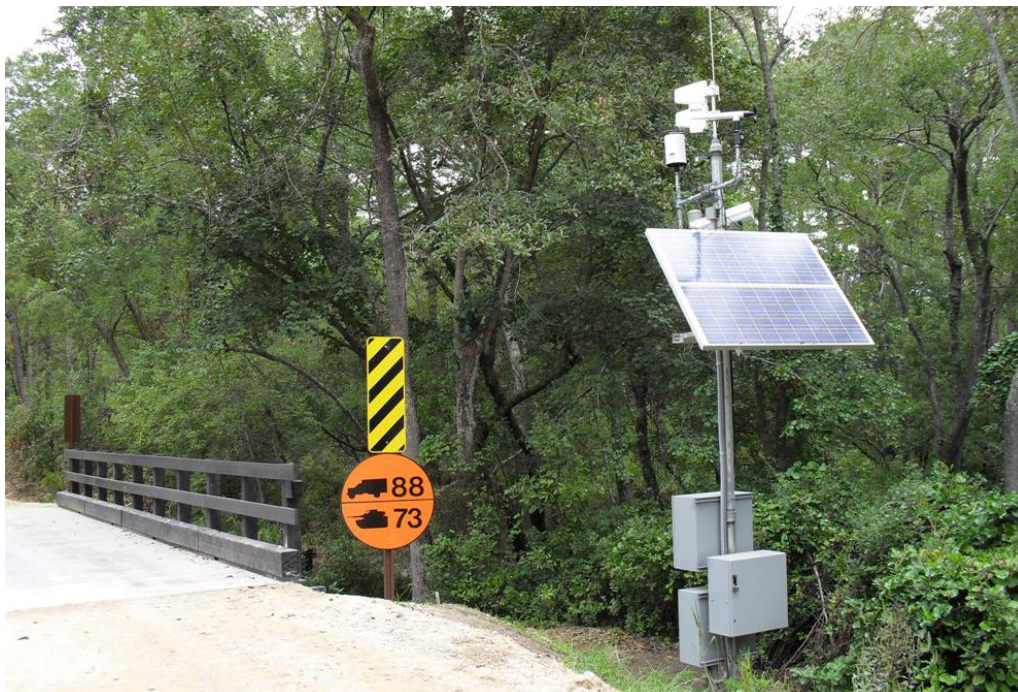
Figure 33. Weather gauges and a camera are part of the remote performance monitoring setup at right.

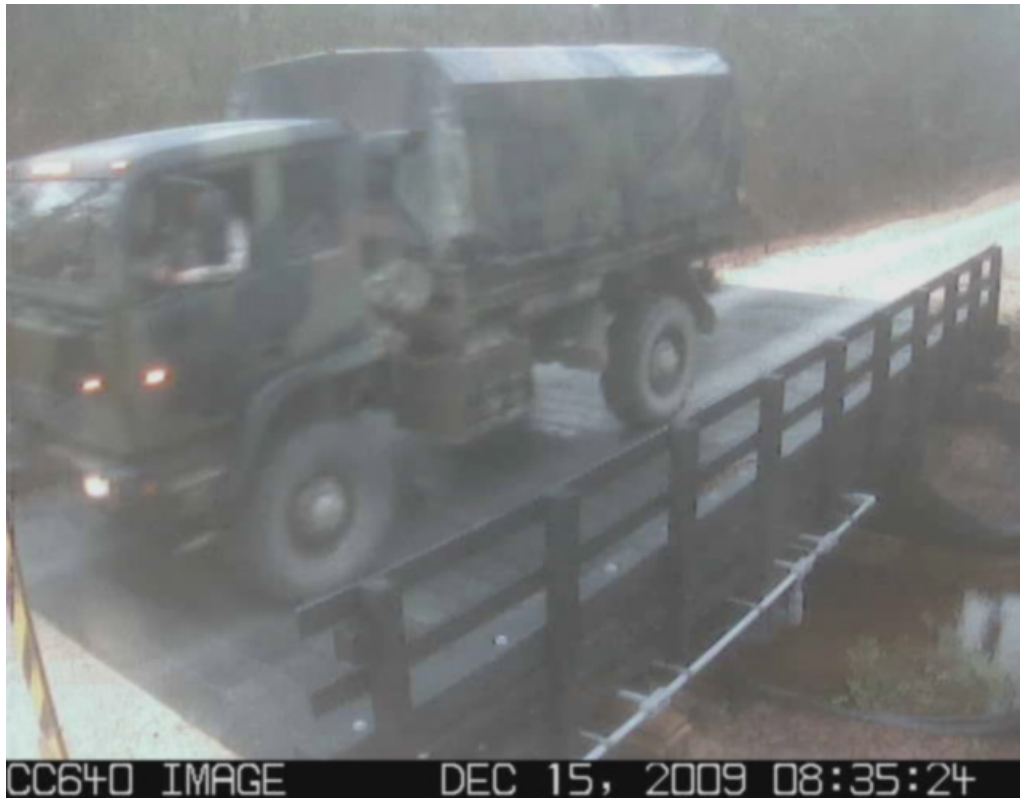
Figure 34. A remote image system is activated by a vehicle crossing. Initial settings had to be tuned down as the system was so sensitive at first it was detecting deer crossings.

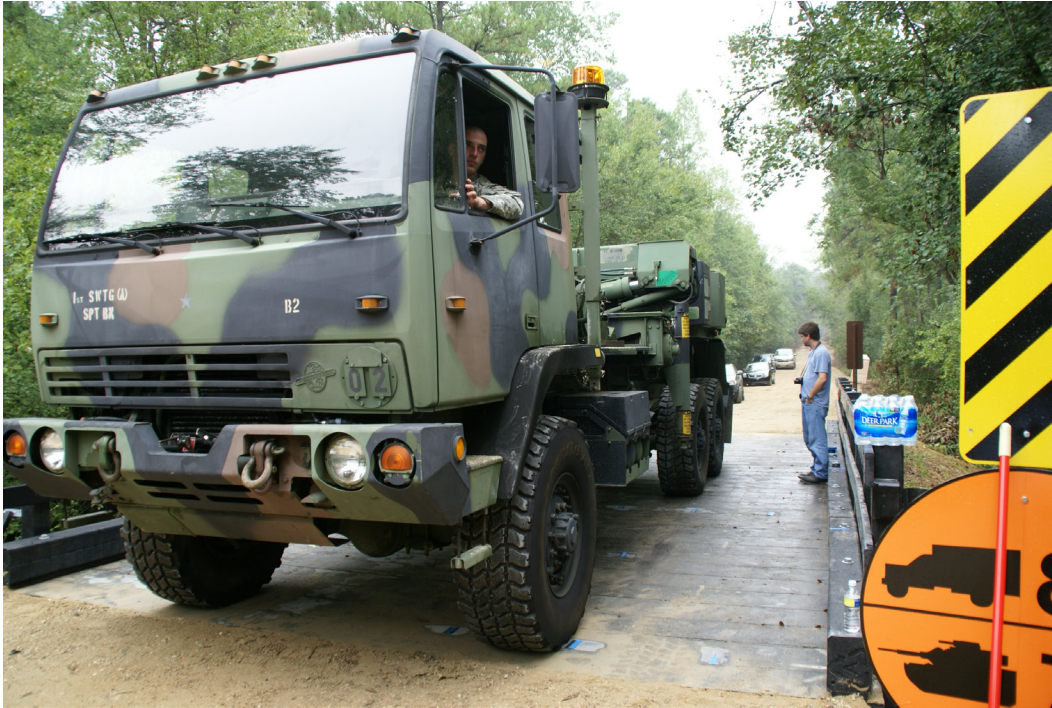
Figure 35. Wheeled M1089 Wrecker is positioned for load testing of Bridge T-8518.

Additional load tests were conducted in August 2010 using an approximate 17-ton (15.4 Mg) wheeled M1089 Wrecker (Figure 35) and a 70-ton (63.5 Mg) tracked M88A2 Heavy Recovery Vehicle (as a substitute for an M-1 tank which was not available during this time). Initially, the vehicles were driven over the bridge at very slow speeds, stopping at the point of maximum deflection. After five minutes, the vehicle was driven off, and bridge recovery was observed. The vehicles were then driven over the bridge at increasing speed increments that reached 25 mph (40 nautical miles/hr) to observe the effects of vehicle speed on the bridge response. The deflections were within the expected values, and there were no indications of creep or material structural degradation when results were compared to previous load tests conducted during September 2009 and January 2010. Details of this later testing are presented in ERDC/CERL TR-11-43 (Lampo et al. 2011).

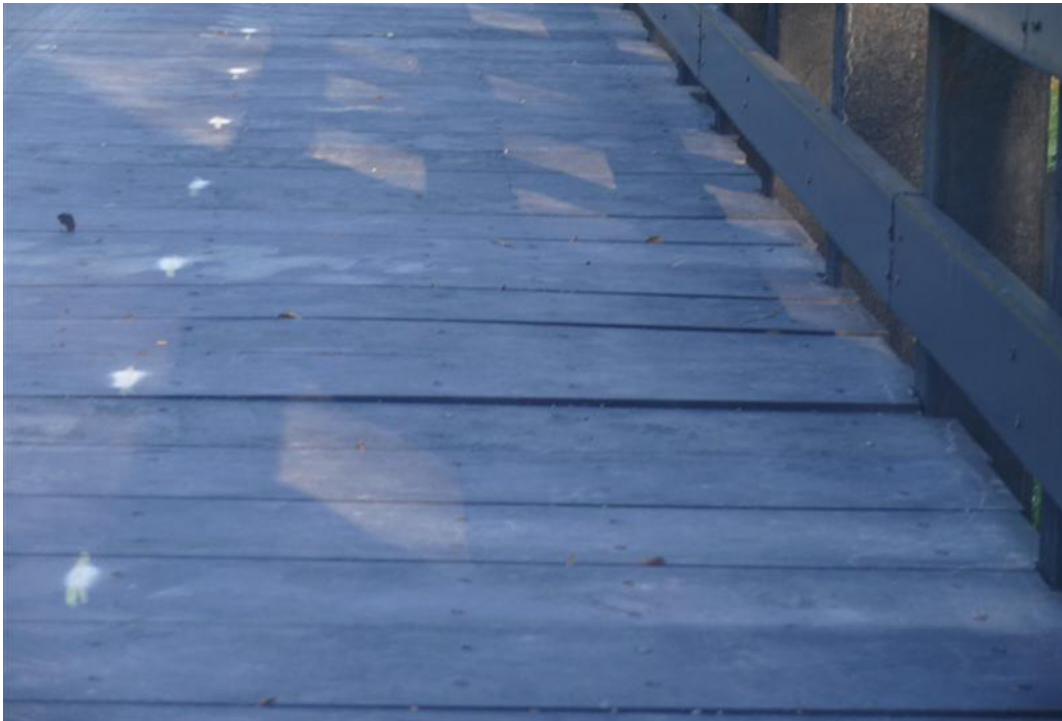
Figure 36. Deck boards showing the sides of Bridge T-8519 loosened and dislodged after the bridge was traversed by a 30-ton (27.2 Mg) steam roller.

After this damage occurred on Bridge T-8519, Dr. Nosker (associate professor at Rutgers University) and Steven Sweeney (ERDC-CERL structural engineer) discussed modifications to the bridges. It was decided to modify Bridge T-8518 before the tank crossing on 11 June. The modifications made to Bridge T-8518 were to insert an additional three screws in the middle of each deck board–girder connection in the outermost four girders (from edges of bridge) along the girder centers.

The modifications on Bridge T-8519 consisted of removing all of the four edge screws that were in place for each of the outermost girder–decking joints and replacing them with longer screws because the dislodged screws were lacking holding resistance. Then, five more screws were placed in the outermost four of the girder–decking interfaces, as per the modification contract’s specifications. Already in place were three screws along the girder’s central axis and one screw at the girder edges on each side between the other screws. The modification resulted in a total of nine screws for each girder–deck board connection for each of the outermost four deck boards on each side of the bridge.

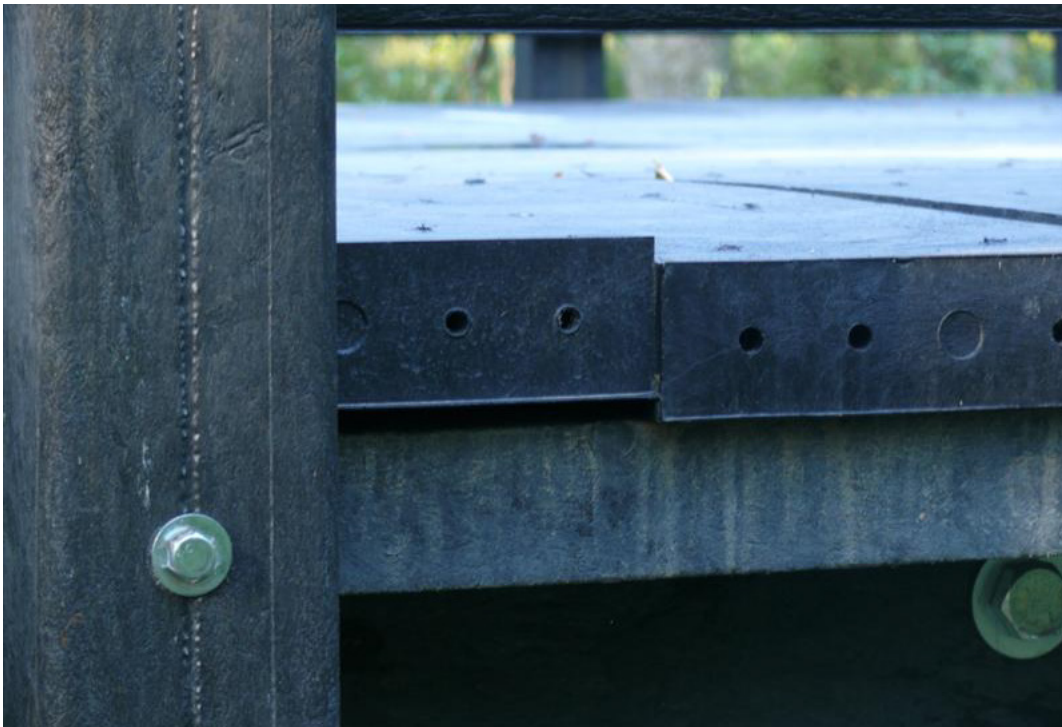
Figure 37. The edge of some deck boards on Bridge T-8519, showing that one board is  $\frac{1}{2}$  in. (1.25 cm) higher than the other.

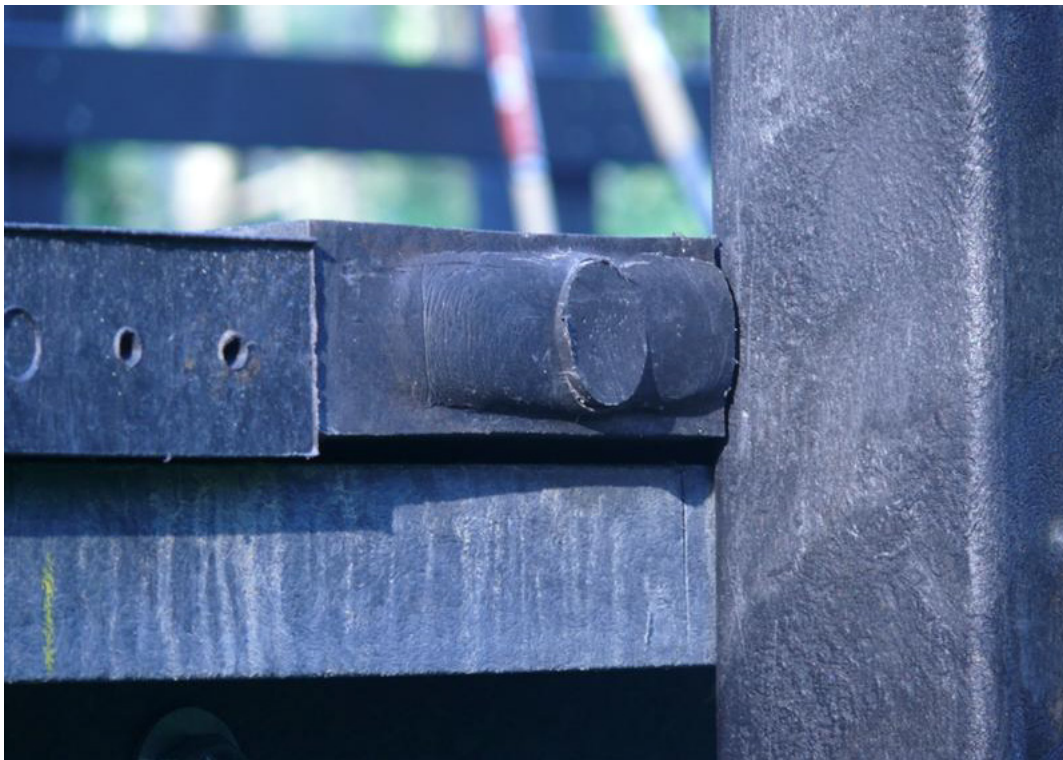
Figure 38. The edge of some other deck boards on Bridge T-8519, showing that one is  $\frac{1}{2}$  in. (1.25 cm) higher than the other.

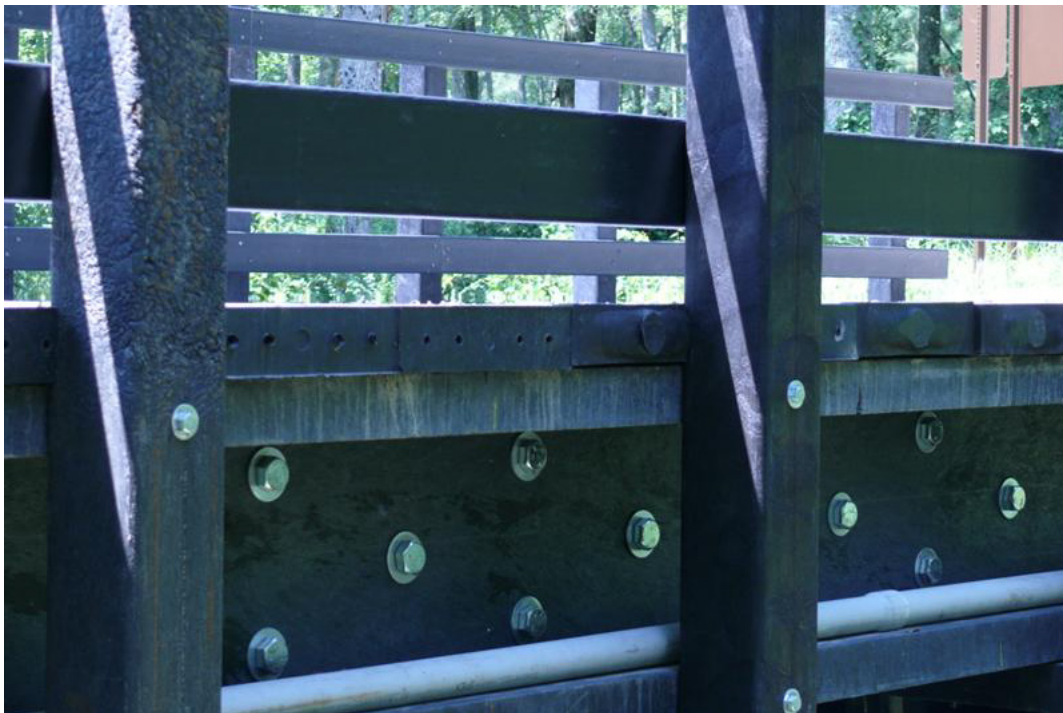
Figure 39. An edge view of Bridge T-8519 after repair of the decking.

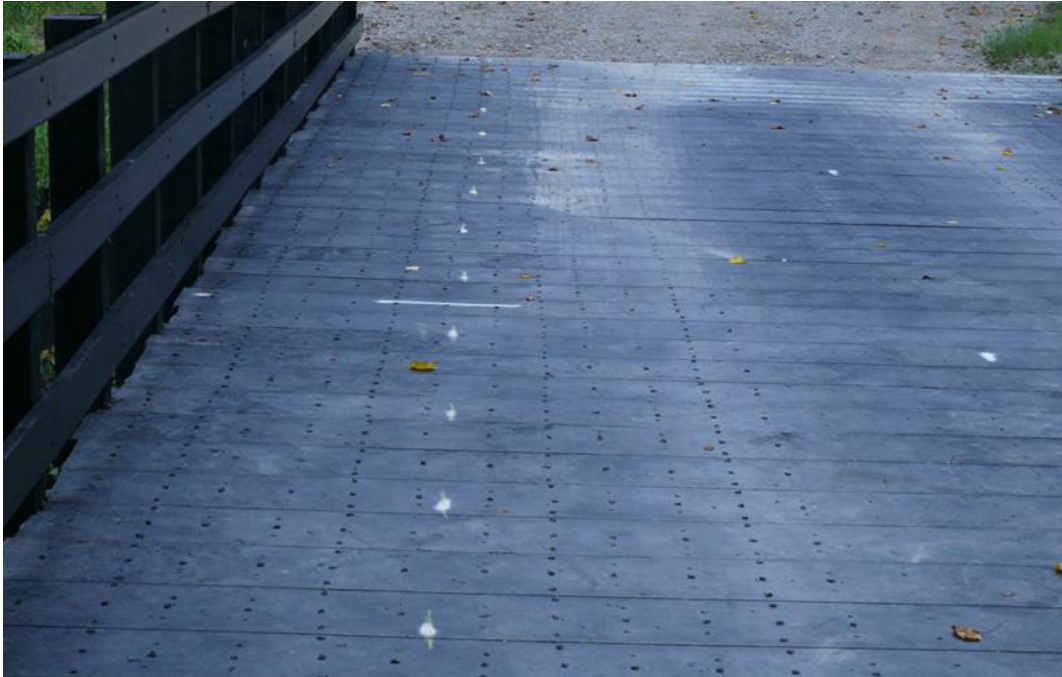
Figure 40. A top view of Bridge T-8519 after repair of the decking.

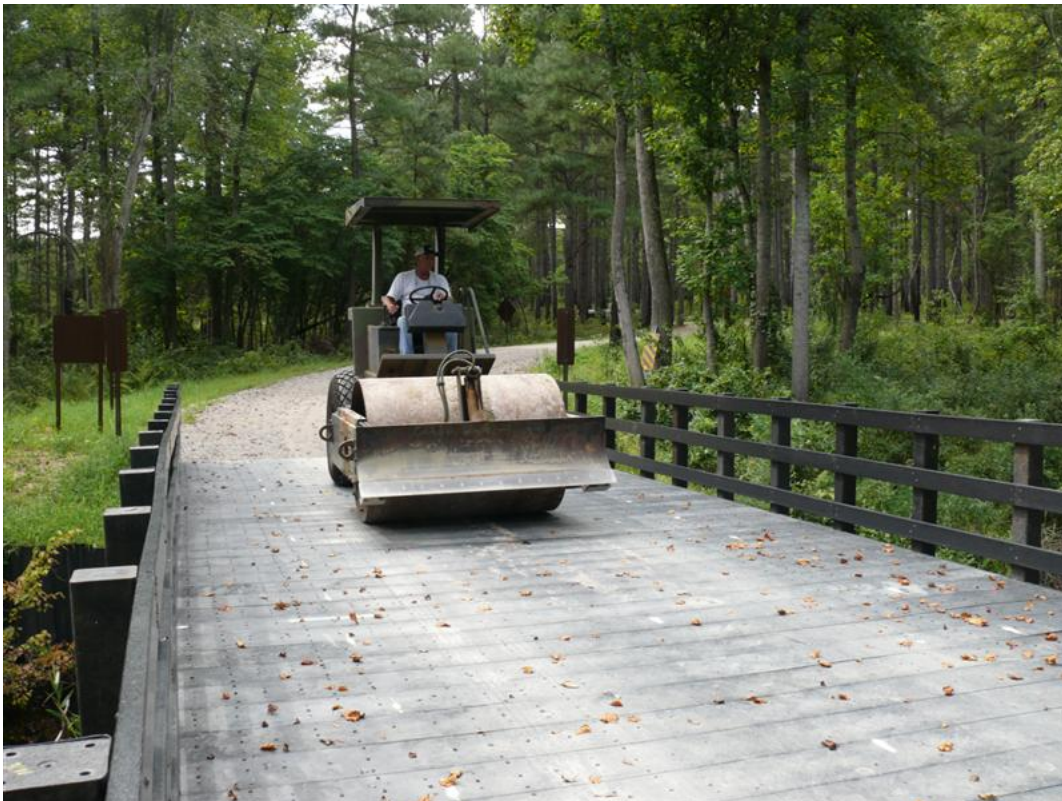
Figure 41. A steamroller crosses Bridge T-8519 after repair of the decking. No noticeable deflections or other types of failures were observed during the crossing.

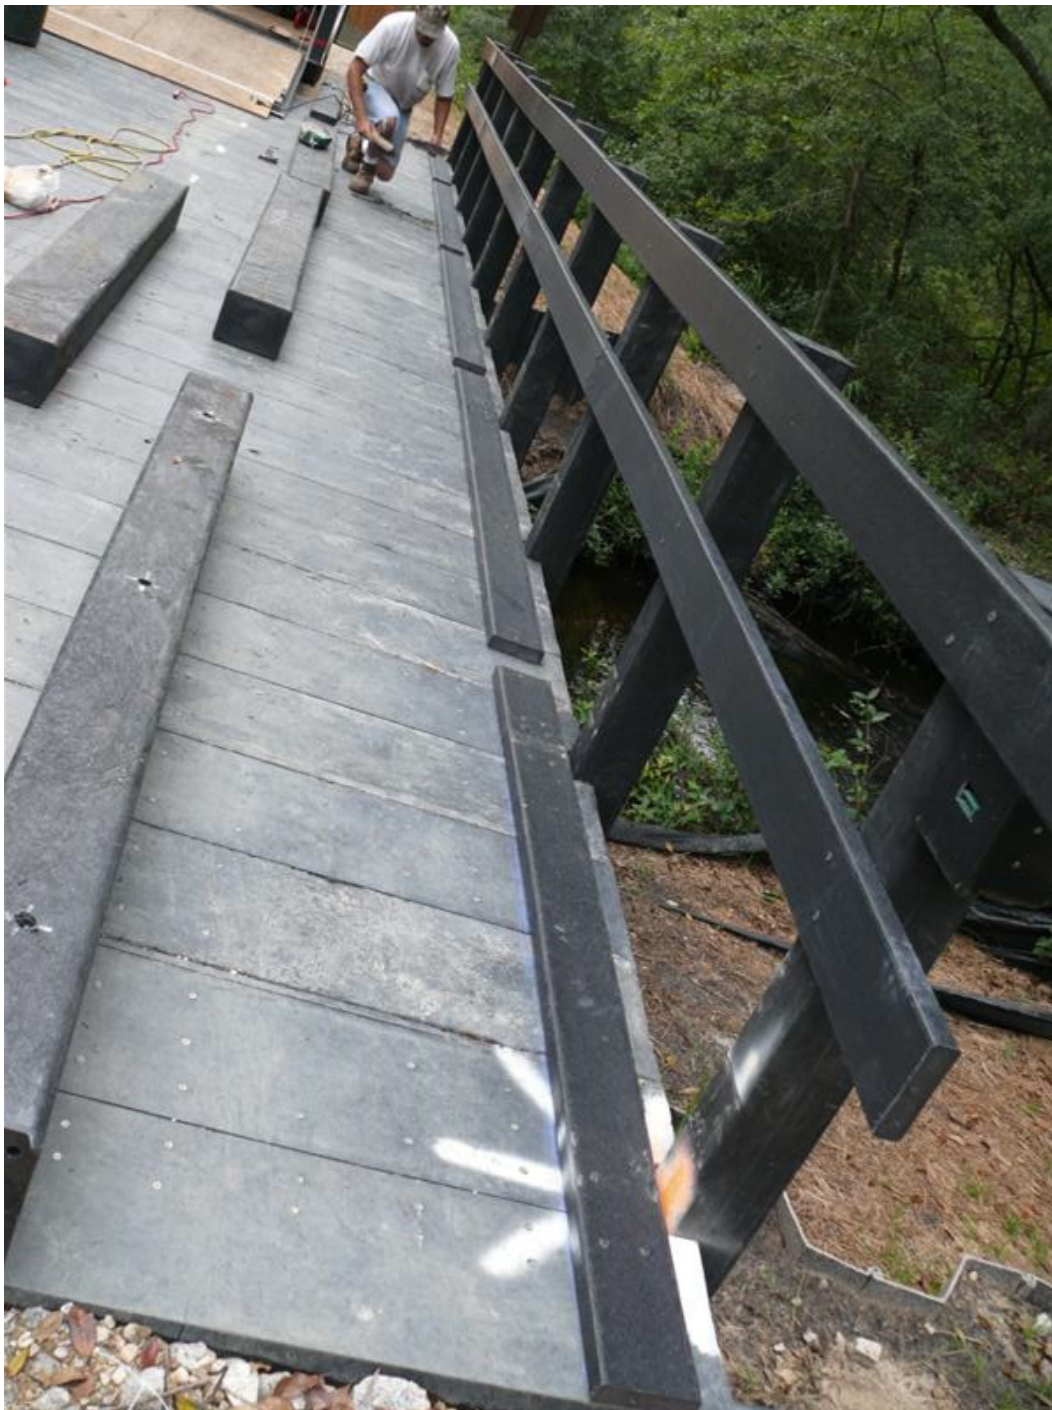
Figure 42. The bottom railing on Bridge T-8518 was removed and fastened to the deck surface, with spaces approximately every 6 ft (1.8 m) to allow water to run off.

A second lesson learned is connected to the first—that is, the bridges as originally designed did not include curbing. This lesson has two implications. The first implication is that any vehicle that is too far off to one side will contact the rails and posts first, almost certainly causing damage to the bridge. The second implication is that the curbing could be thru-bolted through the decking and outer girders, thus holding the deck boards down with a tremendous force. The first modification to Bridge T-8518 specifically addressed this issue and subsequently, curbing was installed as shown in Figure 42–Figure 44.

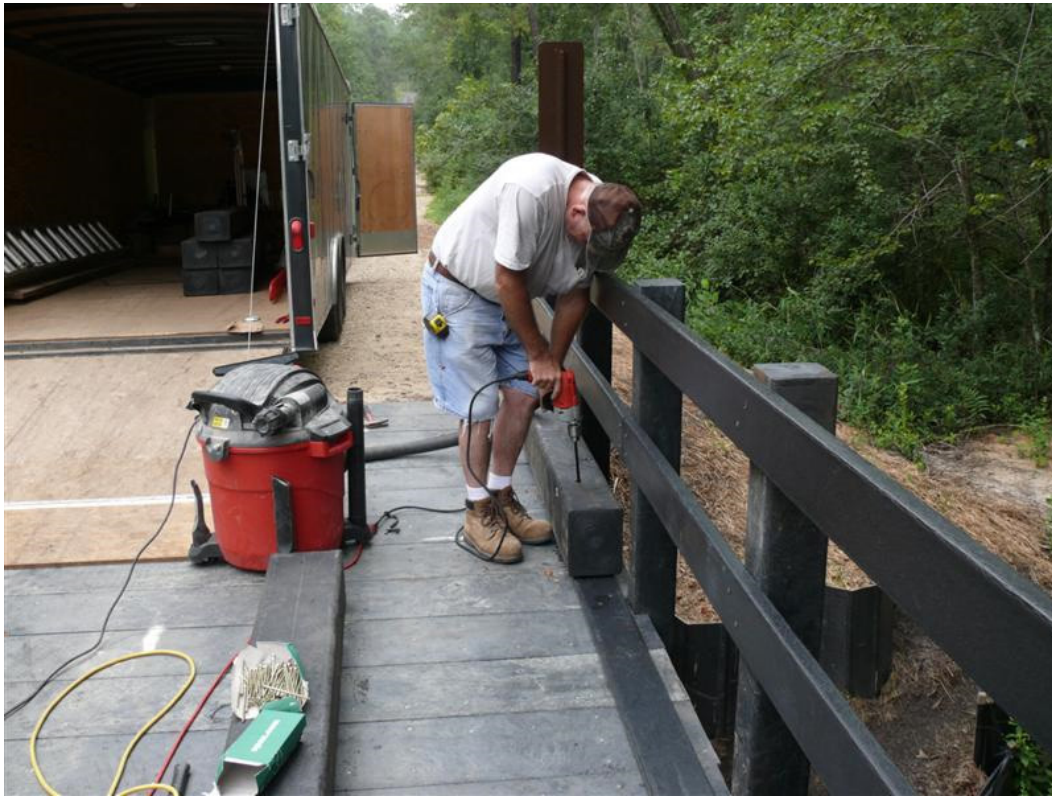
Figure 43. Holes were drilled through the decking and girder substructure to allow for a thru-bolt connection.

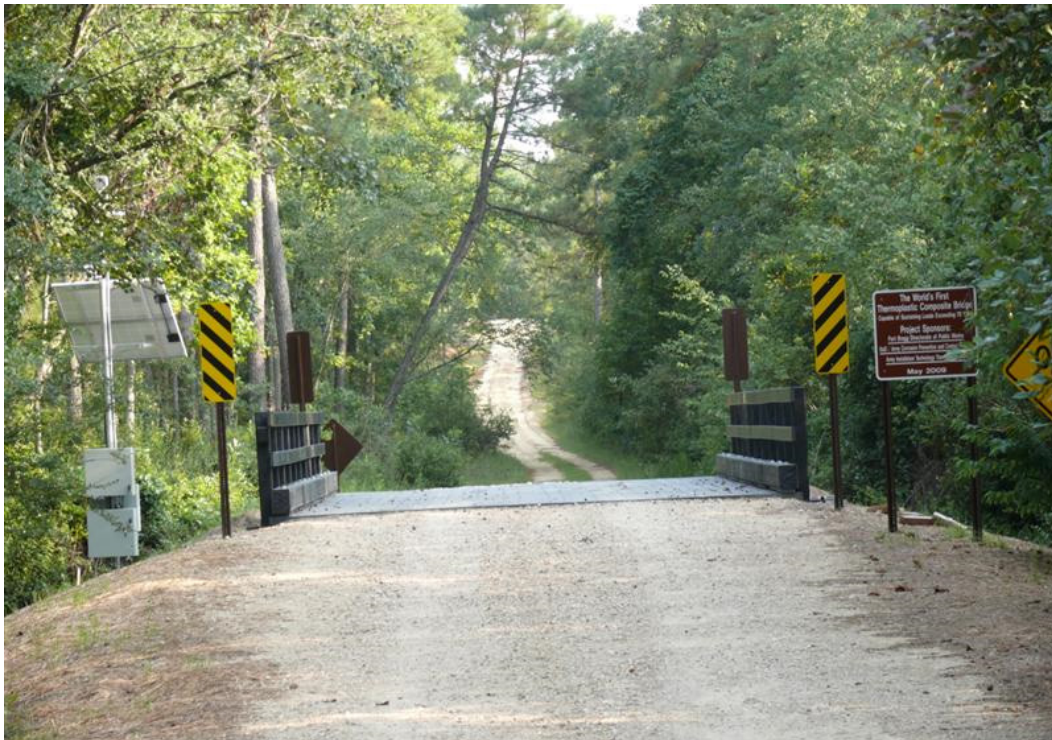
Figure 44. Bridge T-8518 with the rub rails installed.

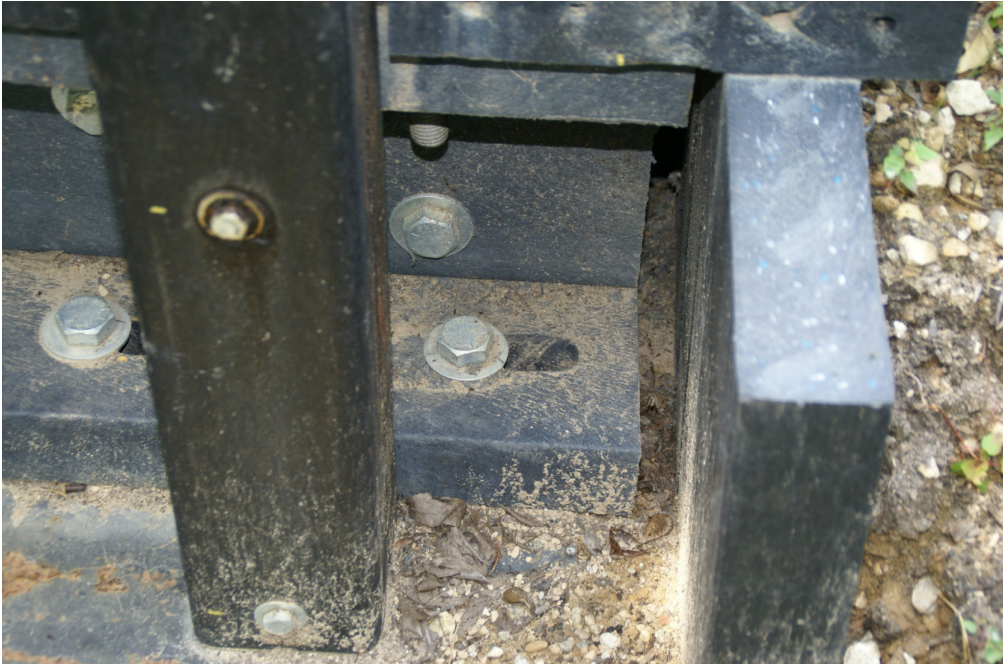
Figure 45. Slotted connections to accommodate thermal expansion/contraction.

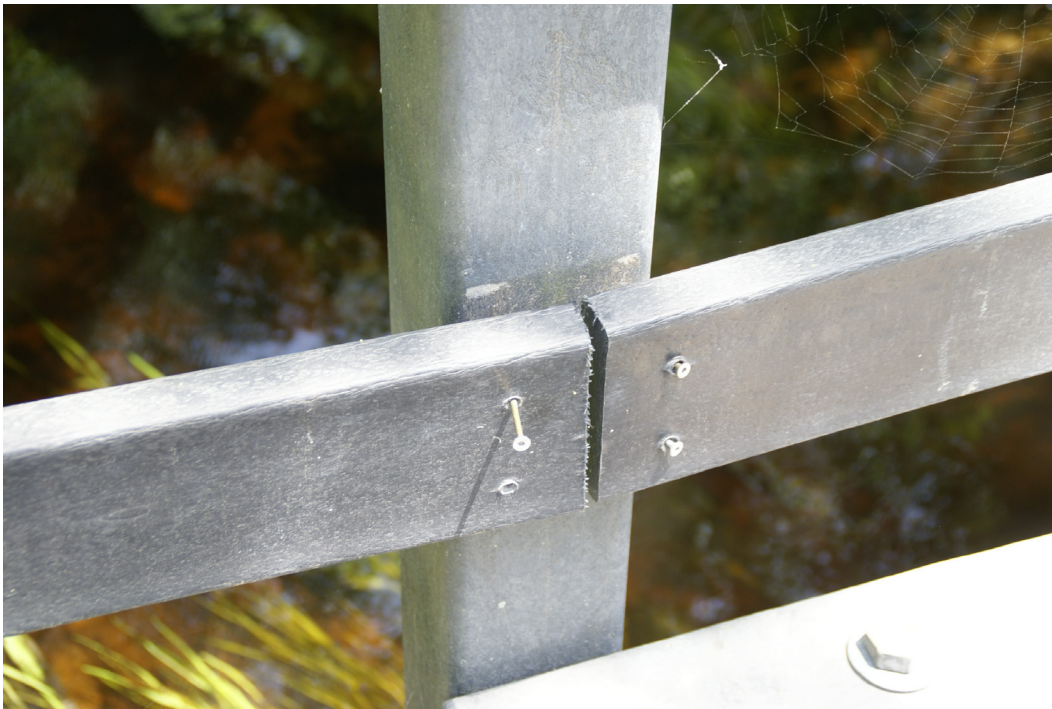
Figure 46. Observed problem of screws holding the railing boards that pulled out from the post at the ends of the boards as a result of forces exerted by expansion-contraction of the railing boards.
